Manhole Inspection Summary

Manhole # S33KK_039MH

Insp Date: **3/26/07 1:21 PM**

Location Address: **1900 NORTH AVE**

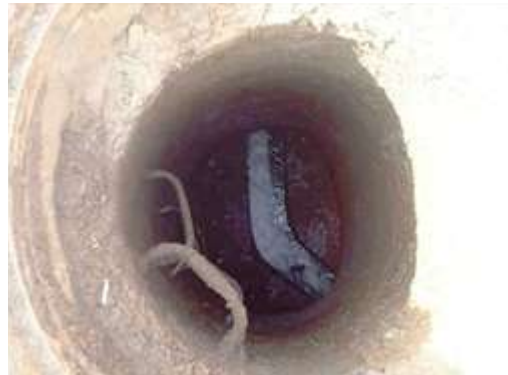
Top View

☒ **Debris** (not Condition related)

Count: **6** Missing: **0** ☒ **Corroded**

Corroded steps. Bench debris.

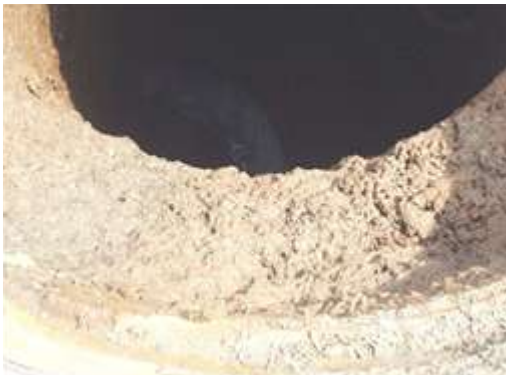
Defect

Offset: **4** (in.)

☒ **Leaks**

Frame leaks. Frame offset.

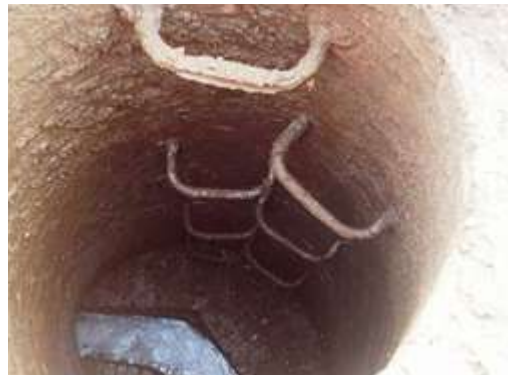
Defect

Infiltration: ☐ None ☒ **Joint** ☐ Cracks ☐ Mortar ☐ Roots ☒ **Wall**

Frame offset. Adjustment infiltration.

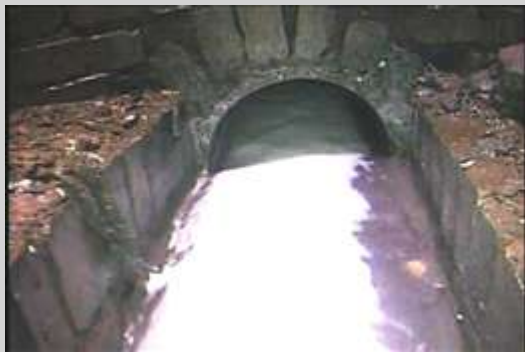
10 in. Circular Gravity Sewer Pipe Out @ 12 O'Clock

Condition: ☐ Sound ☐ Cracked ☐ Root Intrusion ☐ Loose Brick ☒ **Deteriorated**

Infiltration: ☐ None ☐ Joint ☐ Cracks ☒ **Mortar** ☐ Roots ☐ Wall

Condition: ☐ Sound ☐ Cracked ☐ Root Intrusion ☒ **Deteriorated** ☐ Leaks ☐ Debris

Barrel deterioration and infiltration. Channel deterioration.

Infiltration: **None** Pipe Seal Cond: **Cracked**
